Successful Rebuilding After Previous Ruidoso Flood Proves it Can be Done

Full Mitigation Best Practice Story

Lincoln County, New Mexico

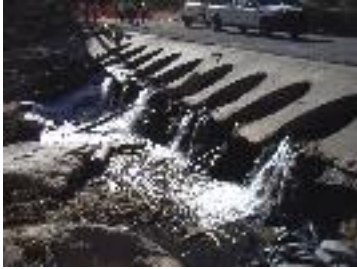
Gavilan Canyon Road bridge debris-clogged culverts after 2006 flood event.

After the floodwaters subsided, village officials inspecting the bridge crossing discovered heavy debris clogging. A video camera extended into the 30-foot length of each corrugated metal culvert revealed the reasons. "What the camera showed was rusted metal with giant cavities around five of the culverts. The only thing holding the bridge [together] was the concrete on top of it," said J.R. Baumann, Street Director for the Village of Ruidoso. The Gavilan Canyon bridge was considered extensively damaged.

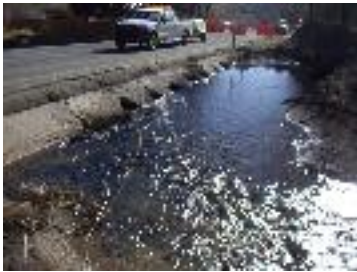
Gavilan Canyon Road bridge continued water pooling on upper-river side after 2006 flood event.

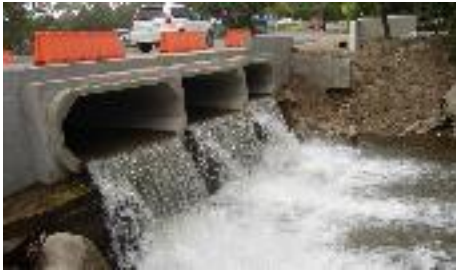
The Gavilan Canyon Road bridge new culverts after 2008 mitigation.

In March 2008, the crossing was closed to traffic and the damaged culverts removed. Three new culverts with a 3-foot by 5-foot capacity were installed. The river banks were widened and covered with gravel and the upstream side "straightened" and expanded to allow better flow. A new pedestrian walkway was added to the bridge with exterior handrails installed. However, custom guardrails for the interior that were ordered had not arrived in time for the Memorial Day weekend opening.

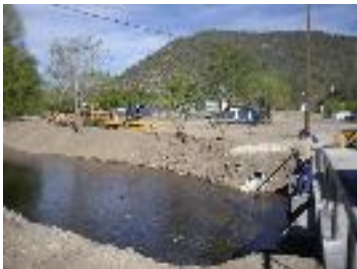
Dirt work expansion of upper-river side at Gavilan Canyon Road bridge after 2008 mitigation.
